Manhole Inspection Summary

Manhole # S06AA2001MH

Insp Date: **7/10/06 10:46 AM**

Location Address: **6901 REISTERSTOWN RD** Cross Street: **LABYRINTH RD**

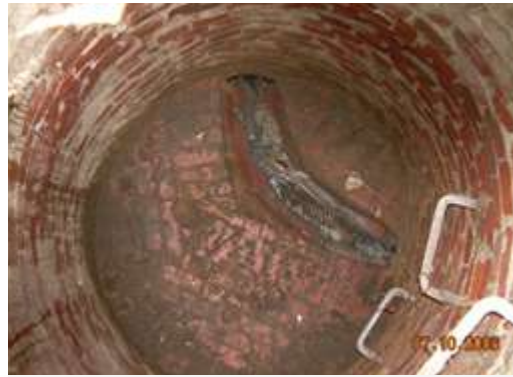
Top View

Adjustment, Corbel, and Barrel infiltration.
Evidence of surcharge - Bench debris.
Channel debris.

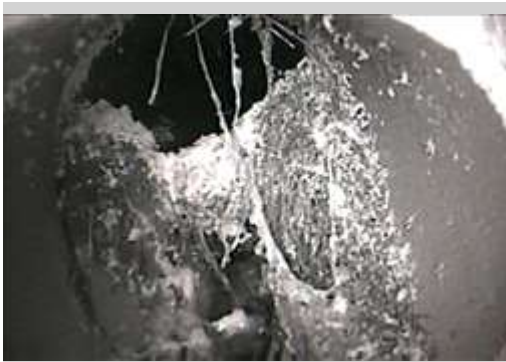
Inside of the I4

Comments **The O12 pipe picture shows Channel deterioration. The I4 pipe picture shows root intrusion inside of the pipe.**

Roots/Debris

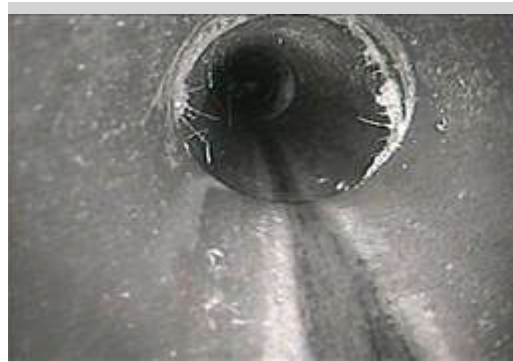
Inside of the O12

Offset Joint and roots

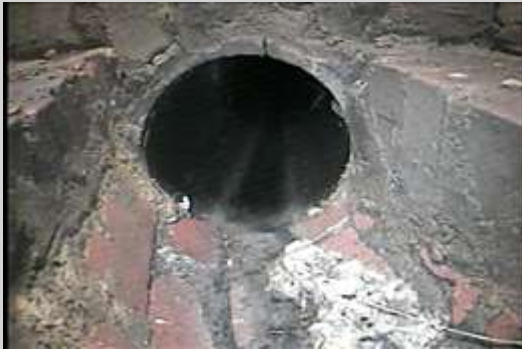
8 in. Circular Gravity Sewer Pipe Out @ 12 O'Clock

Deposits: ☐ None ☐ Mud ☒ **Sludge** ☐ **Debris** ☒ **Grease**

Infiltration: **None** Pipe Seal Cond: **Cracked**

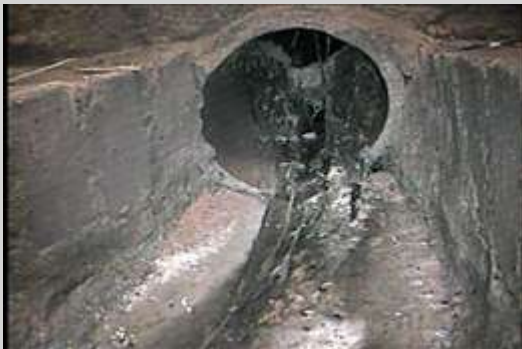
6 in. Circular Gravity Sewer Pipe In @ 4 O'Clock

Deposits: ☐ None ☐ Mud ☐ Sludge ☒ **Debris** ☐ Grease

Infiltration: **None** Pipe Seal Cond: **Cracked**
